An Investigation of Stream Channel Modifications at Unauthorized Suction Dredging Sites on the South Fork Clearwater River, October 7 and 8, 2015

Dan Kenney
North Zone Fisheries Biologist
Nez Perce-Clearwater National Forests
February 3, 2016

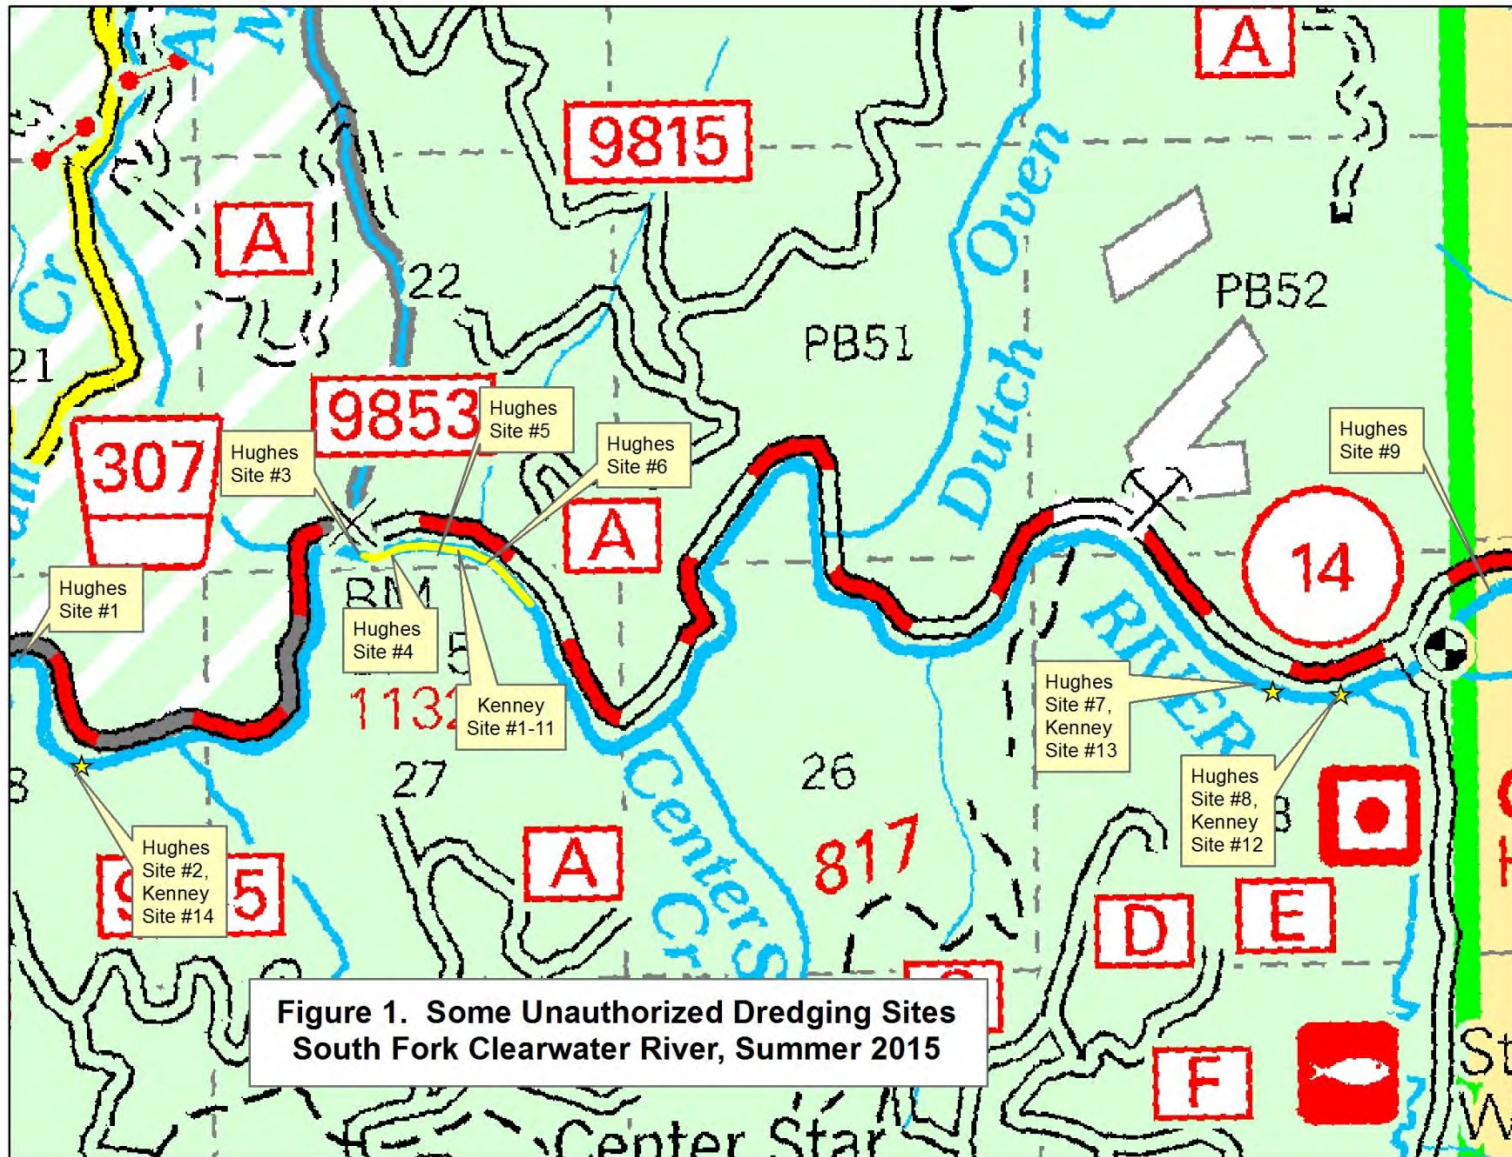
Figure 1. Locations of July (Hughes, text box) and October (Kenney, text box and yellow stars) dredging site observations on the SFCR. Kenney Site #1-11 are too close together to show stars and so this reach is designated by a yellow line. The length of the SFCR reach between Hughes Site #1 and Hughes Site #8 is about 4.5 miles. The western edge of the Elk City township is on the far right.

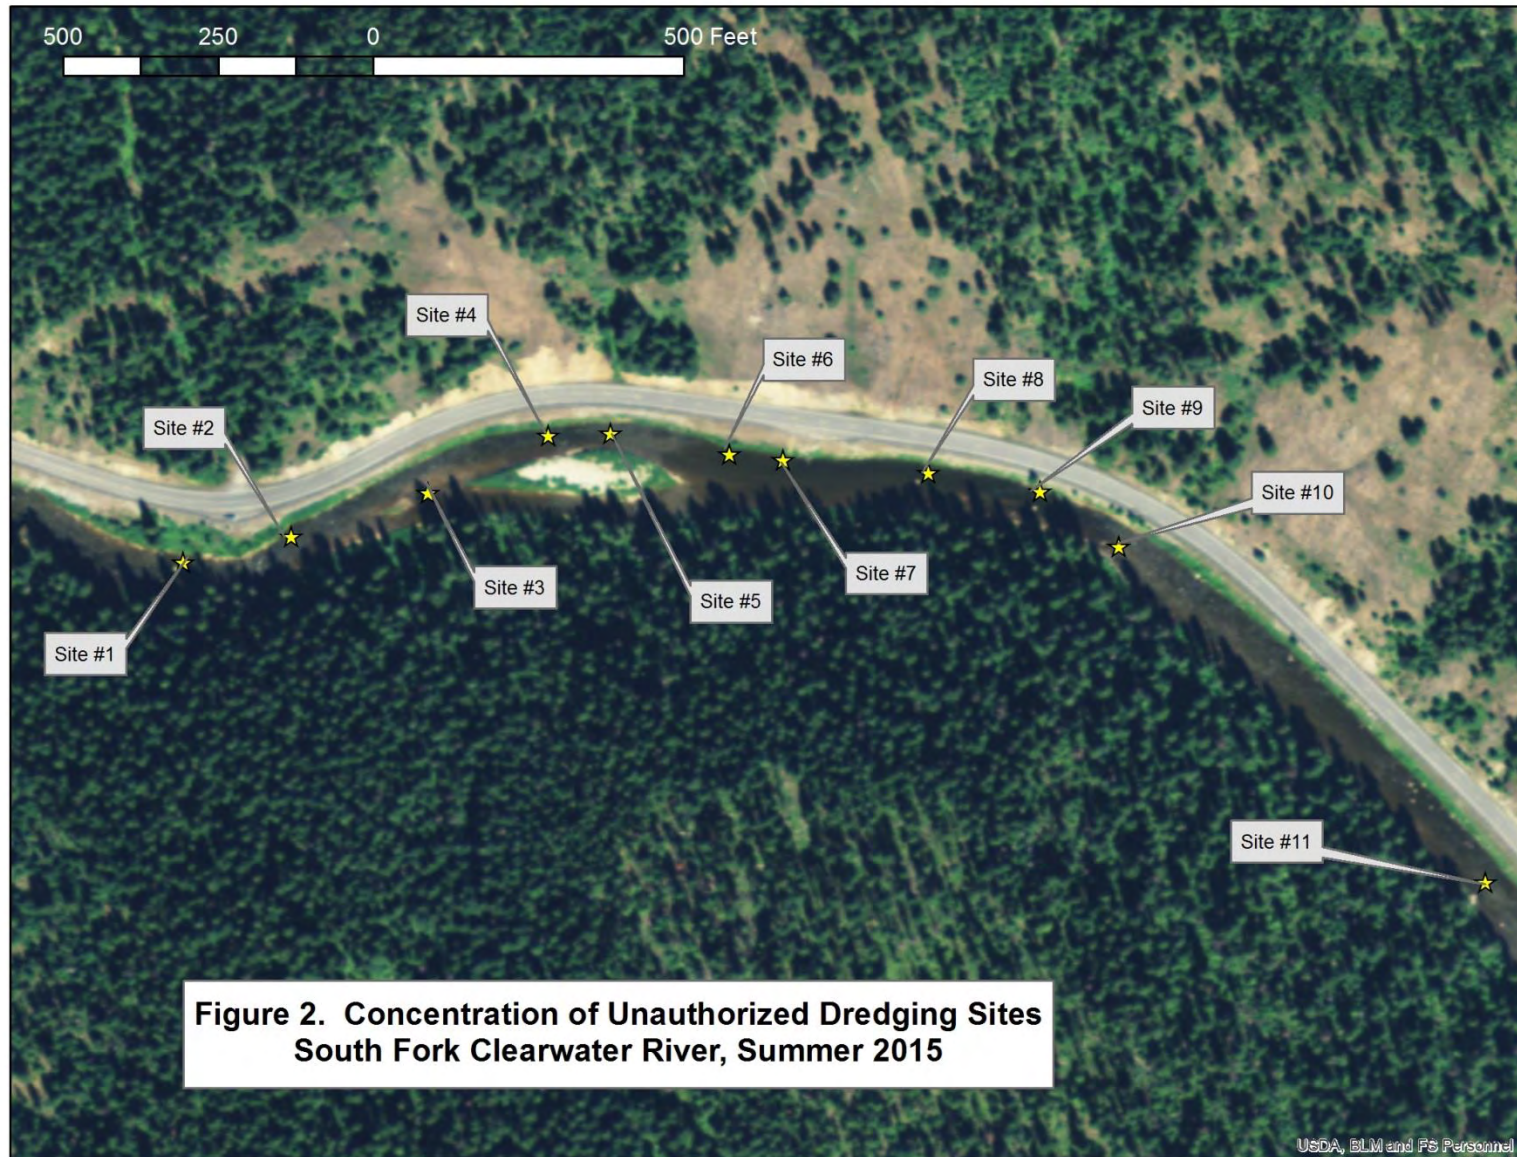
Figure 2. Aerial photo showing locations of concentrated area of October (Kenney, text box and yellow stars) dredging site observations on the SFCR; this figure shows the location of sites designated in Figure 1 by a yellow line. The stars show the upstream-most edge of the upper dredge hole for each site. The length of the SFCR reach between Site #1 and Site #11 is about 2,500 feet. Note proximity of Idaho 14 to river.
